# **Premises Fire Safety Risk Assessment.**

## *Fyndoune Community College*

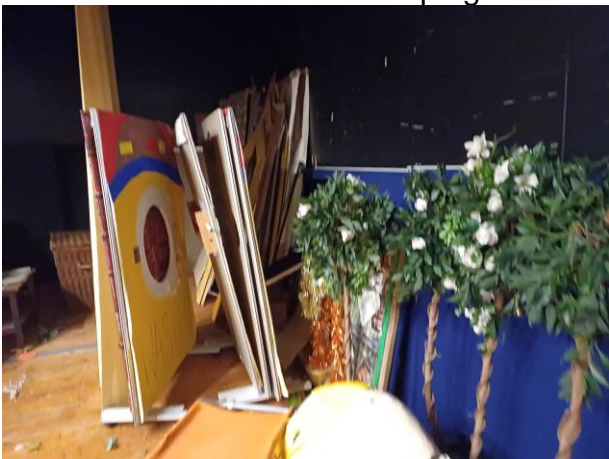
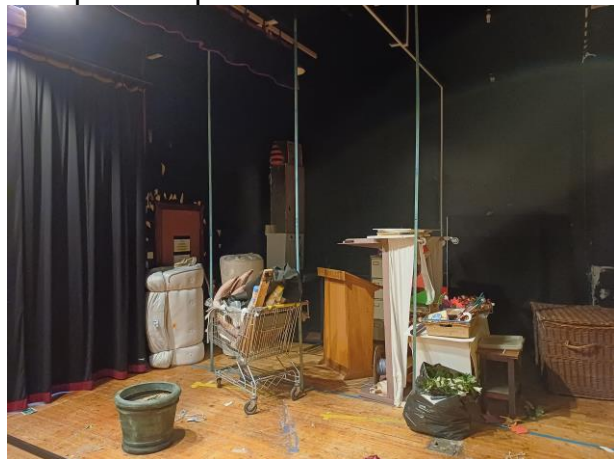
Housekeeping throughout the premises was to a good standard generally. One area of concern was the main stage area in block 1 which was being used for storage of combustible items. Housekeeping in this room required improvement. **Action 3.1**

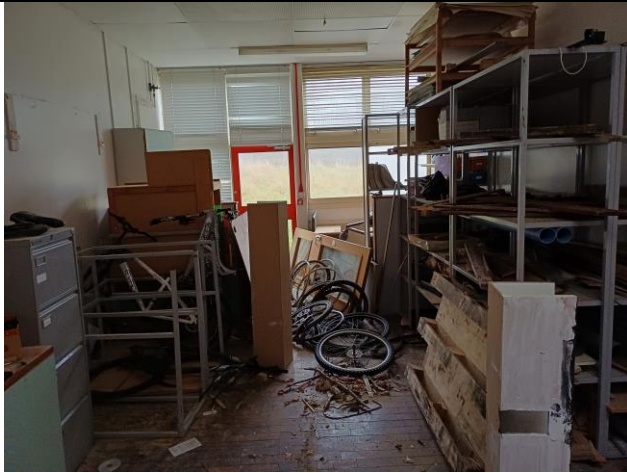
The woodworking store in block 1 which has been vacated was found to contain a lot of redundant combustible items, this has been left by the previous occupants which was Education +. **Action 3.2**

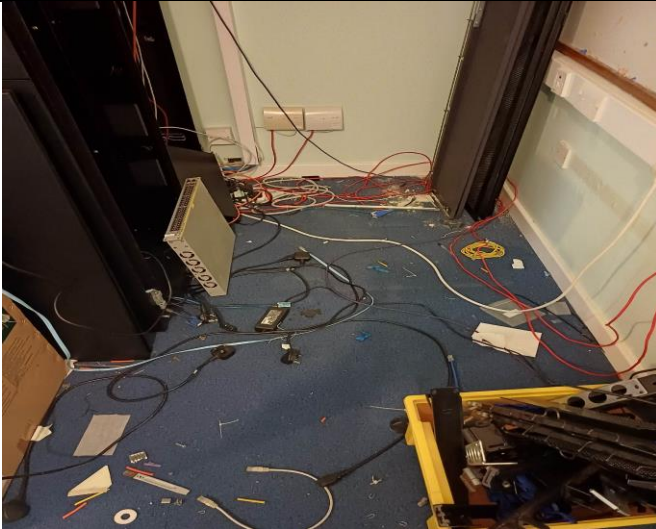
There is a server room located on the first floor of block 1, housekeeping in this room has improved since the initial FRA was completed, however there are still numerous redundant electrical items within this room that appear to be superfluous and there is evidence of multi ganging of sockets. **Action 4.1**

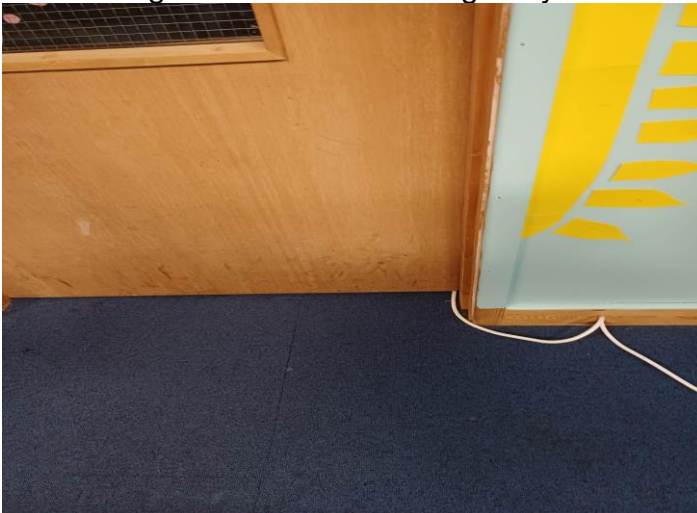
A trailing lead for a projector was in use in the Technicians room, this lead was connected to a socket in the server room, thus it was under the door thresh and it is foreseeable that this training lead would be damaged by the closing door. **Action 4.2**

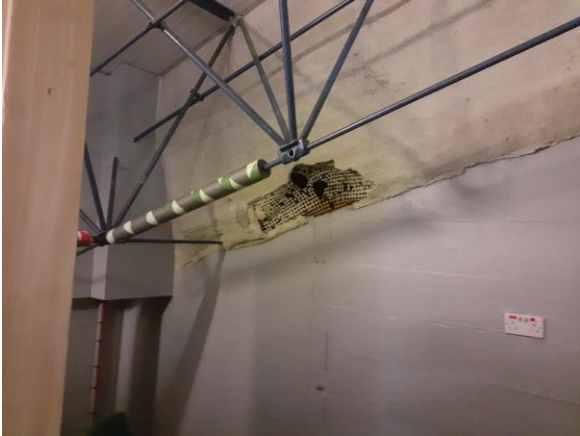
The fire barrier to the first floor PE classroom within the sports hall has been damaged. However, this is a property protection issue and not a life safety concern and as such this has not been included within the action plan to be repaired. If this area is to be reoccupied, then arrangements should be made to have this repaired.

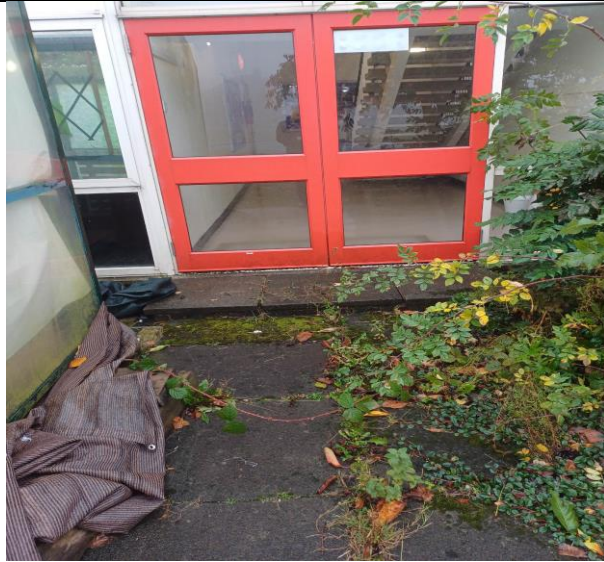
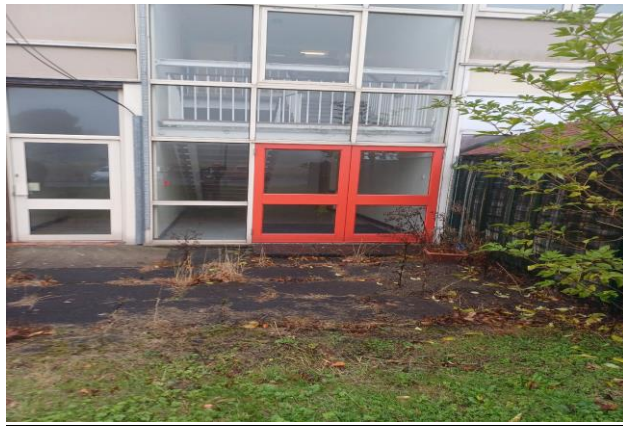
It was identified that footpaths outside of the means of escape to the ground floor exits in block 1 require moss/vegetation removal as they were overgrown and the exit door nearest to the private nursery boundary fence was partially obstructed with a tarpaulin/sheet. **Action 11.1**

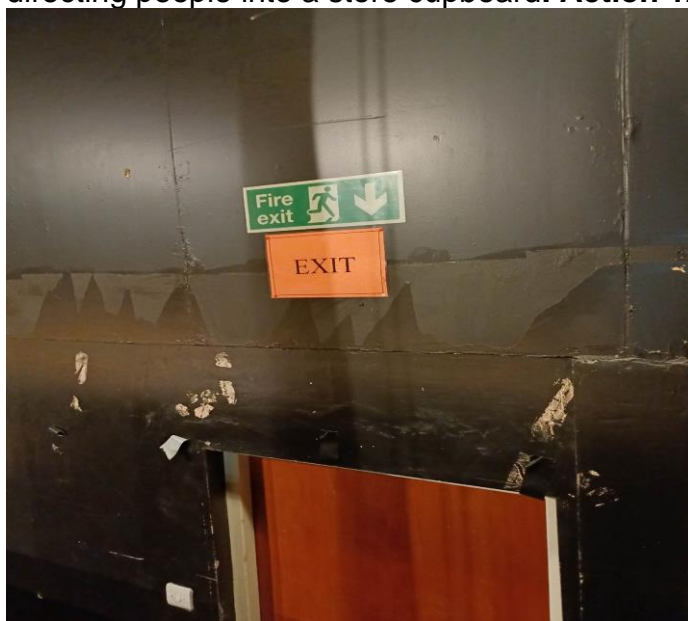
The emergency exit sign above the door to the storeroom should be removed as it is directing people into a store cupboard. **Action 12.1**
