# **Durham County Council**

## **Premises Fire Safety Risk Assessment.**

# **Fyndoune Community College**

**May 2026**

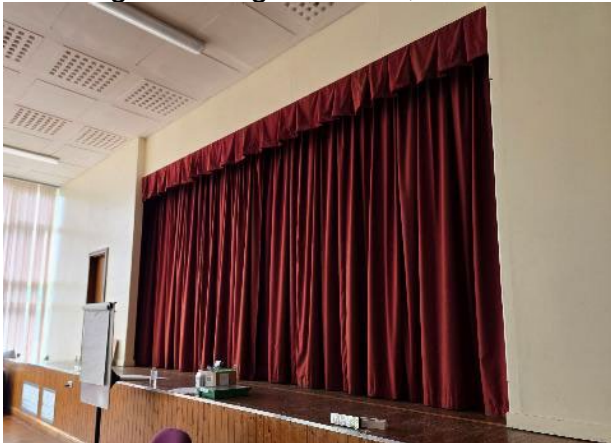
The stage has large curtains; these are of a flame-retardant material.

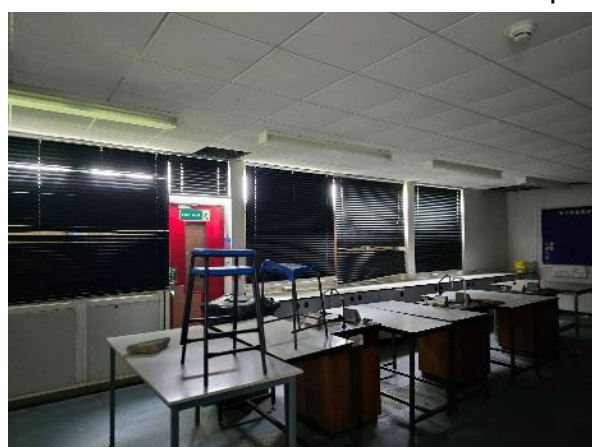
The science & Technology area have fixed furniture still in some rooms. As the area is unoccupied and there have been several break-ins some windows are boarded up.

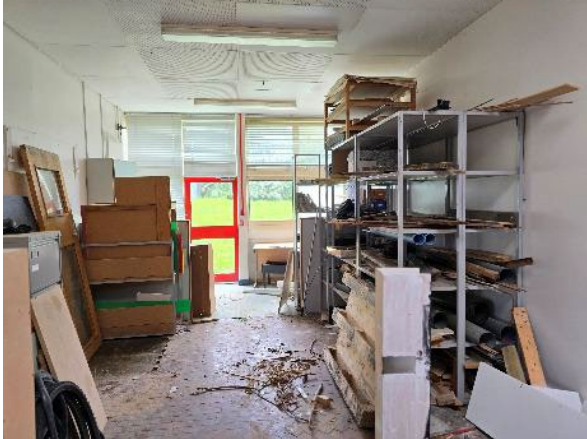
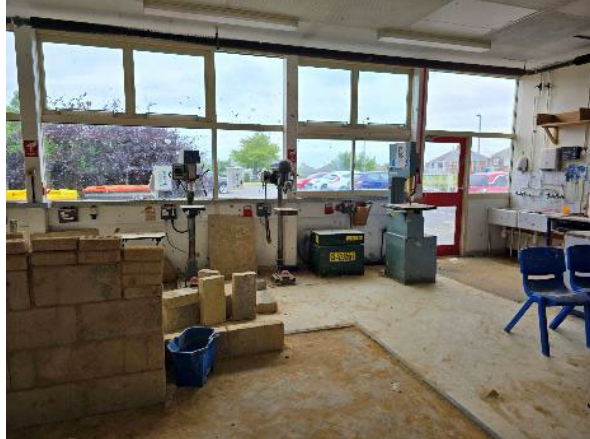
The old woodworking area in block 1 still has combustible items, this has been left by the previous occupants which was Education +. As this building has been a target for trespasses it needs to be emptied. **Action 3.1**

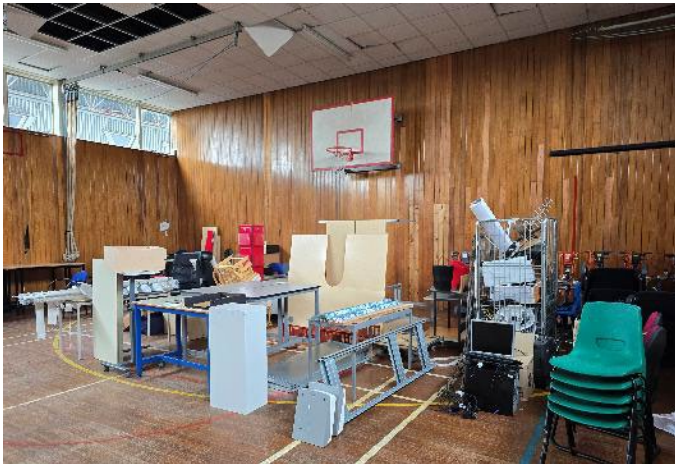
The old gym is no longer used by the school, so is being used for storage, considering the number of break-ins this needs to be emptied to avoid leaving a fuel source for an arsonist. **Action 3.2**

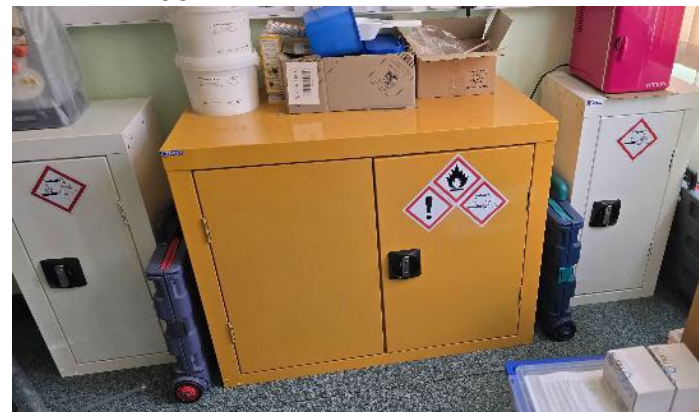
There is a small quantity of flammable chemicals stored in a locked metal cabinet in storeroom 38a on the first floor.

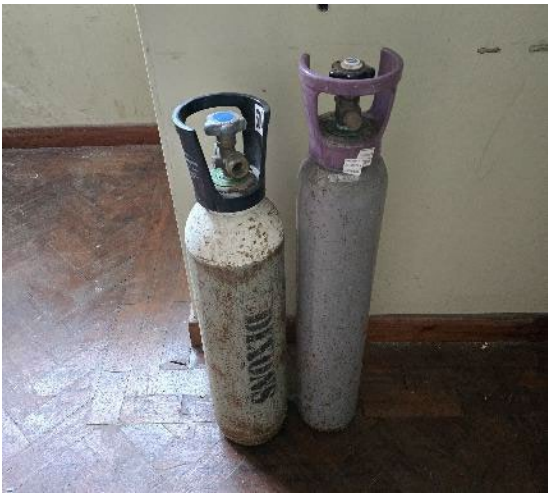
| <p>Natural airflow around the building.</p> <p>The kitchen has mechanical extraction although no longer used.</p> <p>There were no oxygen cylinders within the premise.</p> <p>There were 2 beer gas cylinders found in the Gym, these need to be removed. <b>Action 5.1</b></p> |

| Significant Finding | Priority<br>Low, Medium, High, or Immediate. | Details of Remedial Action (if any) | Person Responsible | Completion Date |
|---|---|---|---|---|
| <b>Action 5.1</b> | <b>Medium</b> | There were 2 beer gas cylinders found in the Gym. These need to be removed. | Business Manager | |

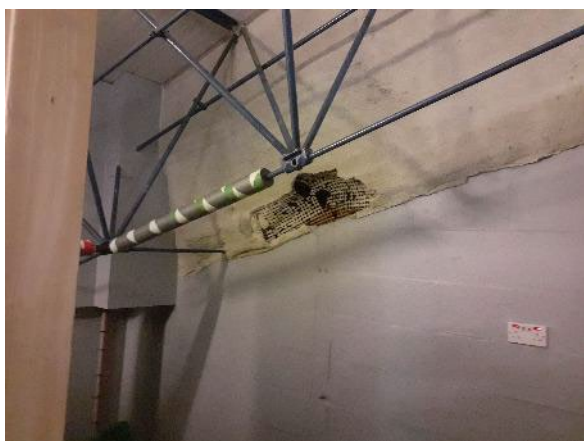
The fire barrier to the first-floor PE classroom within the sports hall has been damaged. However, this is a property protection issue and not a life safety concern and as such this has not been included within the action plan to be repaired. If this area is to be reoccupied, then arrangements should be made to have this repaired.

recommended as the area contains a low amount of fuel sources, good detection system, no ignition sources as well as the fact any repair would soon be undone due to the working practices of the building.

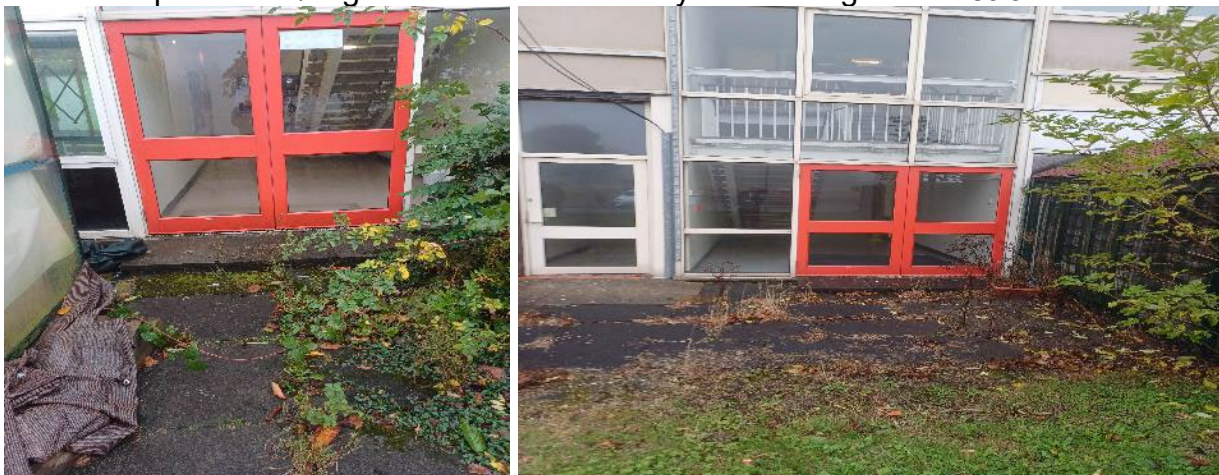
It was identified that footpaths outside of the means of escape to the ground floor exits in block 1 require moss/vegetation removal as they were overgrown. **Action 11.1**
